Your Inspection Report

101 Paradise Drive
Valhalla, ON H0H 0H0

INSPECTION DATE:
Tuesday, September 21, 2010

RE: Report No. 1001
101 Paradise Drive
Valhalla, ON
H0H 0H0

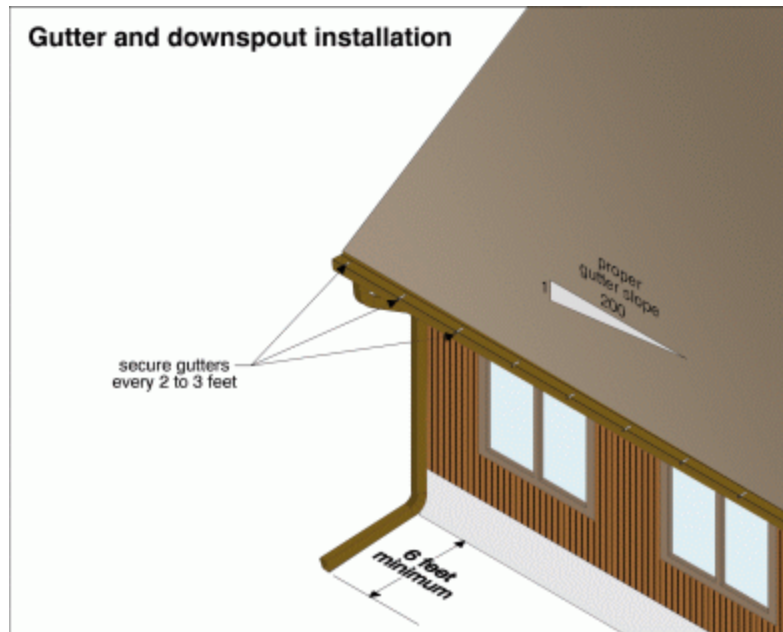
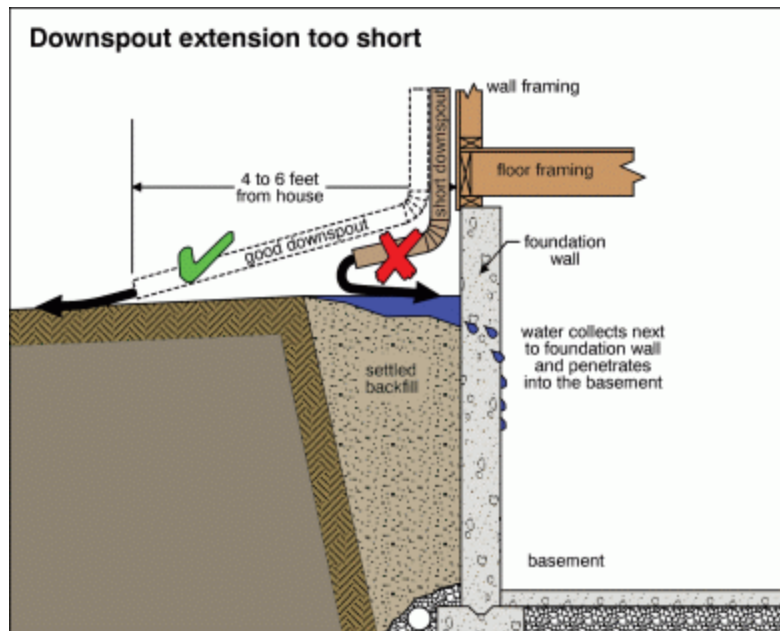
2. Condition: • [Downspouts end too close to building](#)

Concrete spillways are too short

Implication(s): Chance of water damage to contents, finishes and/or structure

Task: Improve

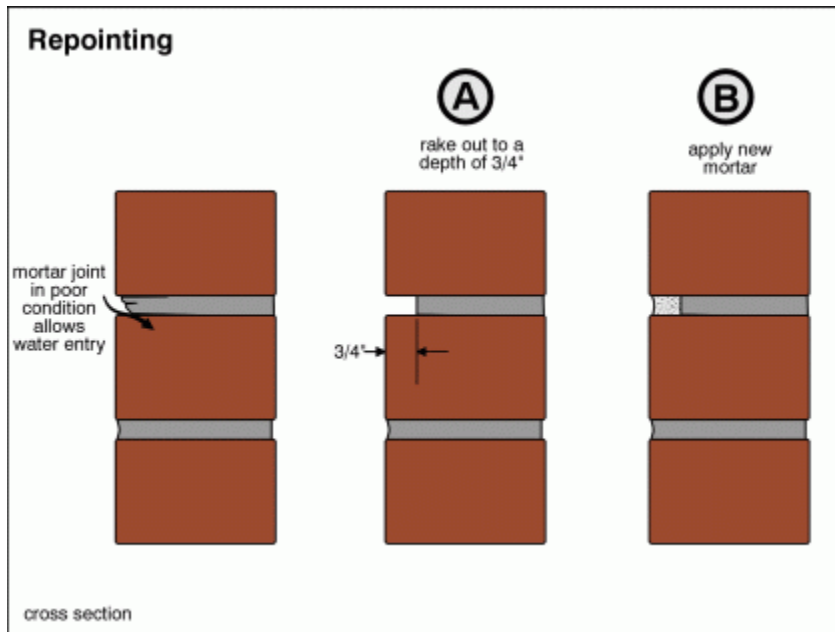
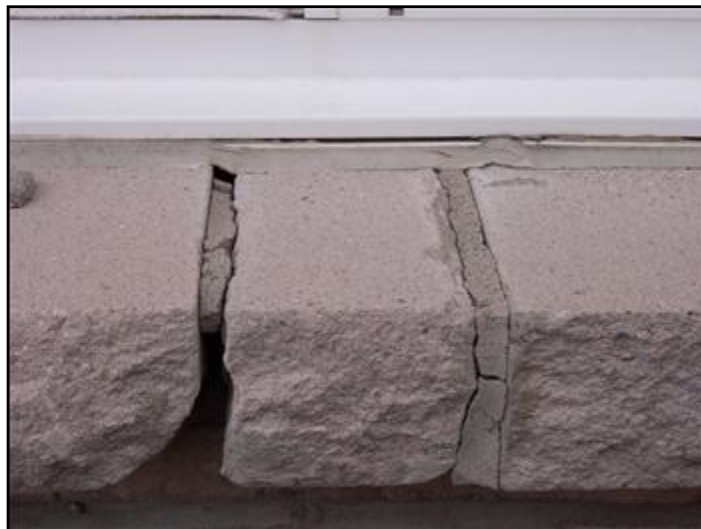
1.

4. Condition: • [Mortar deterioration](#)

Failure to repair masonry window sill extensions could lead to spalling of the bricks under window sills.

Implication(s): Chance of water entering house | Weakened structure | Chance of structural movement

Task: Repair

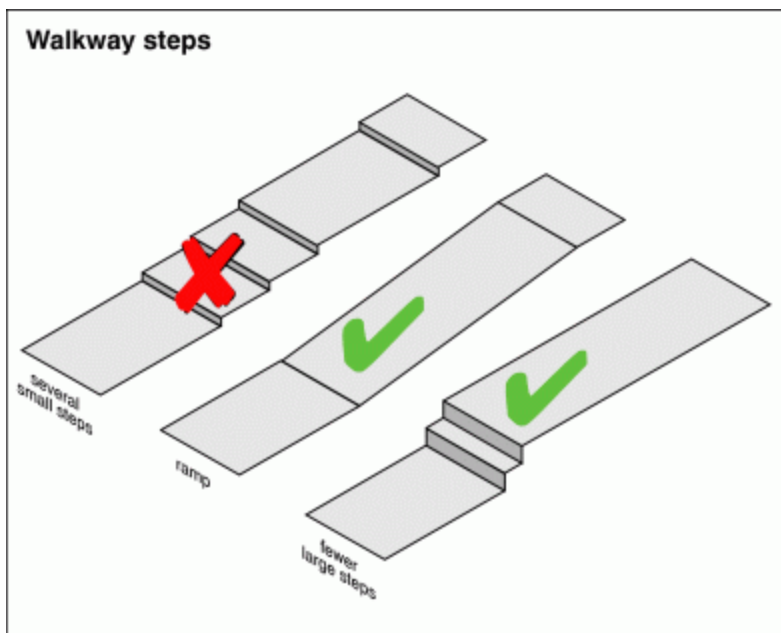
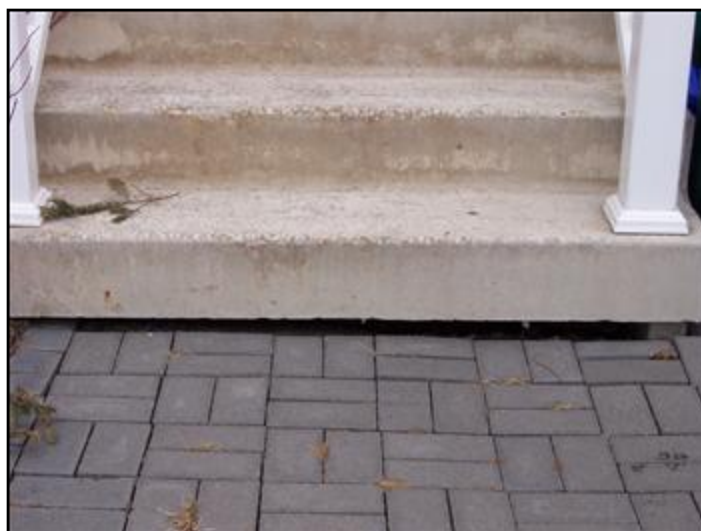
2.

5. Condition: • [Uneven \(trip hazard\)](#)

Settlement of pavers has created a trip hazard, client has indicated that he will be completely changing pavers in front yard.

Implication(s): Physical injury

Task: Repair or replace

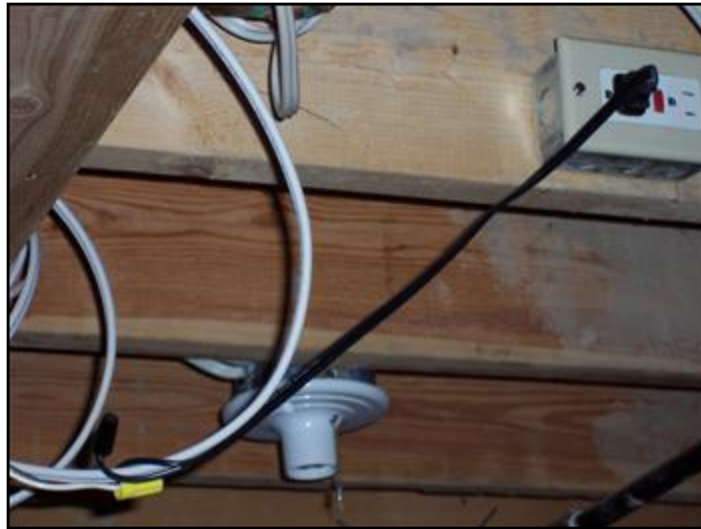
3.

9. Condition: • [Open splices](#)

Open splice on branch going to kitchen pot lights, unplug until repaired

Implication(s): Electric shock | Fire hazard

Task: Correct

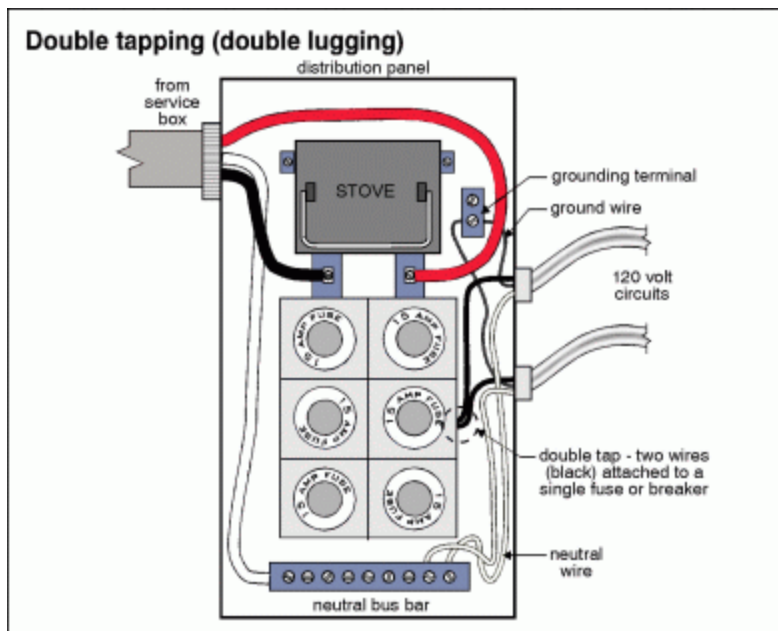
10. Condition: • [Double taps](#)

Wire for doorbell transformer needs to be corrected.

Implication(s): Fire hazard

Task: Correct
